# ASBESTOS MATERIALS REPORT AND REGISTER

St Mark's College,  
James Cook University  
DOUGLAS QLD 4811

**Inspection Date:** 23/11/2016 9:00:00 AM

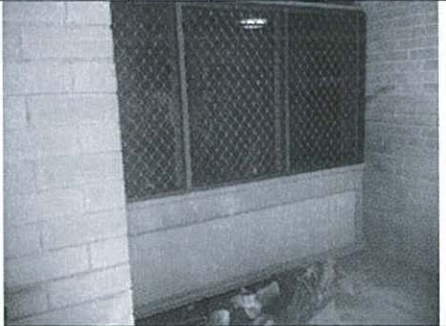
Building	Floor Level	Room	Asbestos in Room	Type	Condition	Priority	Sample No.	Result	Photo
Administration Building	GL	External / Internal	Asbestos cement sheeting to panels under windows with some above windows and doors generally throughout the building.	NF	N	L	E3189	AA	
	25/11/2016	No change in the condition of this item.			N	L

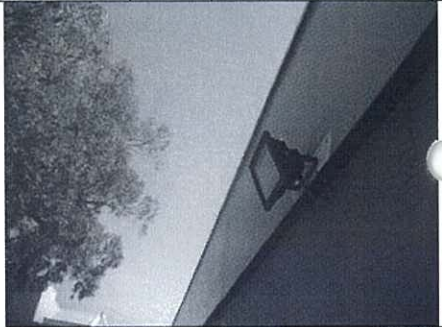
Administration Building	GL	External	Asbestos cement sheeting to fascias generally.	NF	N	L	E3189	CH

Building	Floor Level	Room	Asbestos in Room	Type	Condition	Priority	Sample No.	Result	Photo
25/11/2016			No change in the condition of this item.		N	L

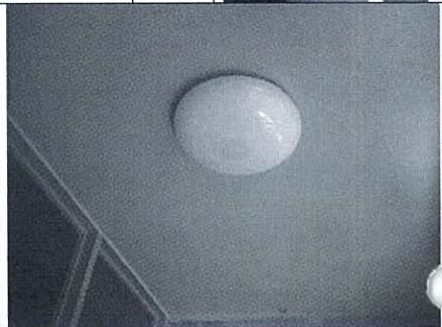
Administration Building	GL	External	Asbestos cement sheeting to soffits generally throughout, including any bulkheads.	NF	N	L	E3189	CH

25/11/2016			No change in the condition of this item.		N	L

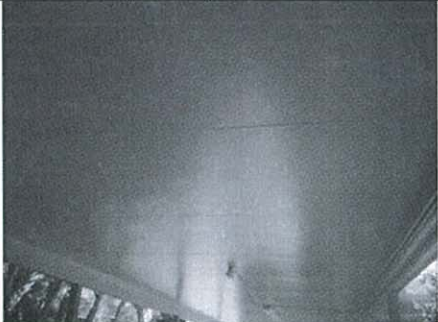
Building	Floor Level	Room	Asbestos in Room	Type	Condition	Priority	Sample No.	Result	Photo
Administration Building	GL	Covered walkway to dining room	Asbestos cement sheeting to ceiling.	NF	N	L	E3193	CH, A

25/11/2016		No change in the condition of this item.			N	L

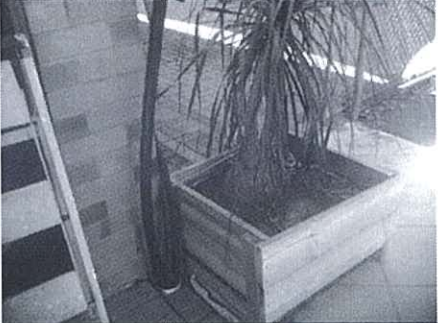
Building	Floor Level	Room	Asbestos In Room	Type	Condition	Priority	Sample No.	Result	Photo
Kitchen / Dining Hall	GL	External - Main entrance	Asbestos to lining to cable pit.	NF	N	L	E0	CH, A

25/11/2016	No change in the condition of this item.				N	L

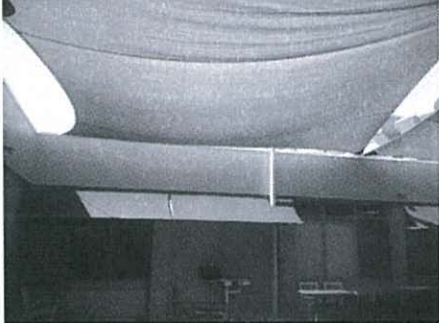
Kitchen / Dining Hall	GL	External - Outdoor seating area	Assumed Asbestos cement vent pipe.	NF	N	L	AA	AA

Building	Floor Level	Room	Asbestos in Room	Type	Condition	Priority	Sample No.	Result	Photo
25/11/2016			No change in the condition of this item.		N	L

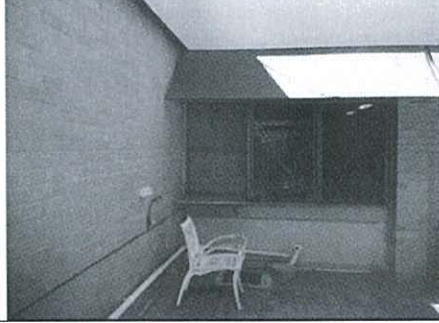
Kitchen / Dining Hall	GL	External / internally	Asbestos cement panel infill's under windows.	NF	N	L	E3194	CH, A

25/11/2016			No change in the condition of this item.		N	L

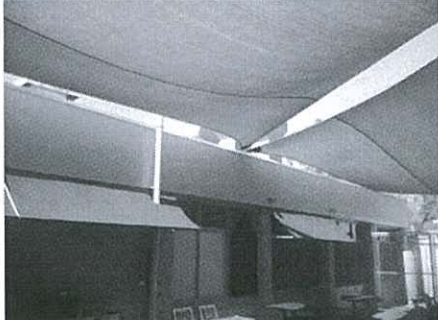
Building	Floor Level	Room	Asbestos in Room	Type	Condition	Priority	Sample No.	Result	Photo
Kitchen / Dining Hall	GL	External	Asbestos cement sheeting to fascias.	NF	N	L	E3196	CH

25/11/2016	No change in the condition of this item.			N	L

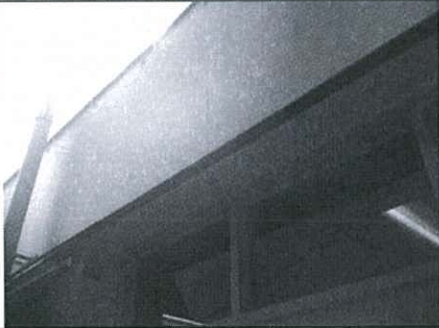
Kitchen / Dining Hall	GL	External	Asbestos cement sheeting to soffits including bulkheads.	NF	N	L	E3196	CH

Building	Floor Level	Room	Asbestos in Room	Type	Condition	Priority	Sample No.	Result	Photo
25/11/2016			No change in the condition of this item.		N	L

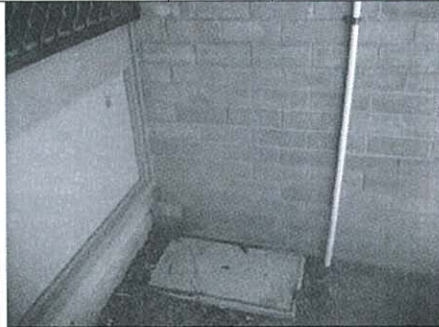
Kitchen / Dining Hall	GL	External - Rear extension	Asbestos cement sheeting to cable pit.	NF	N	L	S3195	CH	
25/11/2016			No change in the condition of this item.		N	L

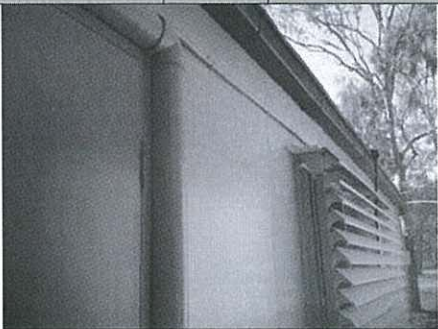
Kitchen / Dining Hall	GL	External - Rear extension	Asbestos cement sheeting to external walls including panels above doors.	NF	N	L	S3195	CH

Building	Floor Level	Room	Asbestos In Room	Type	Condition	Priority	Sample No.	Result	Photo
25/11/2016			No change in the condition of this item.		N	L

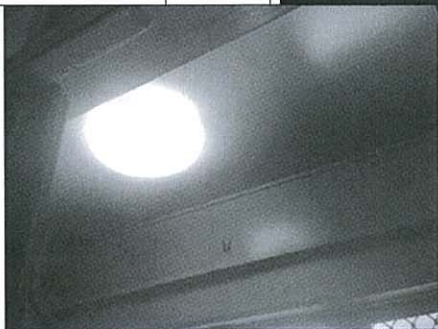
Kitchen / Dining Hall	GL	Main entrance Alcove	Asbestos cement sheeting to ceiling and wall panel.	NF	N	L	E3198	CH

25/11/2016			No change in the condition of this item.		N	L

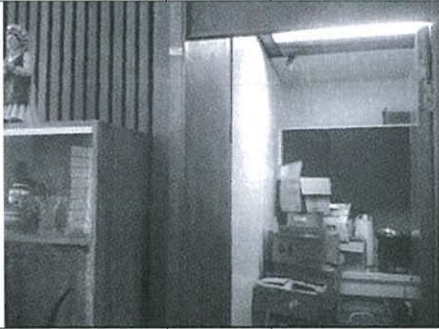
Building	Floor Level	Room	Asbestos in Room	Type	Condition	Priority	Sample No.	Result	Photo
Kitchen / Dining Hall	GL	Store room next to PABX room	Asbestos cement sheeting to walls	NF	N	L	E3198	CH	
	11/2016	No change in the condition of this item.			N	L

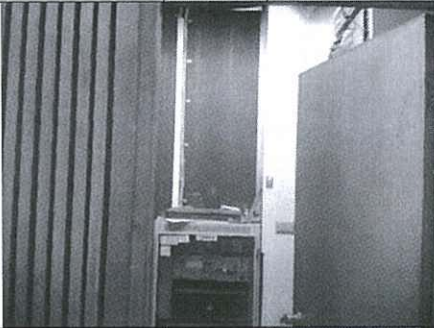
Kitchen / Dining Hall	GL	Server room next to PABX room	Asbestos cement sheeting to walls	NF	N	L	E3198	CH

Building	Floor Level	Room	Asbestos in Room	Type	Condition	Priority	Sample No.	Result	Photo
25/11/2016			No change in the condition of this item.		N	L

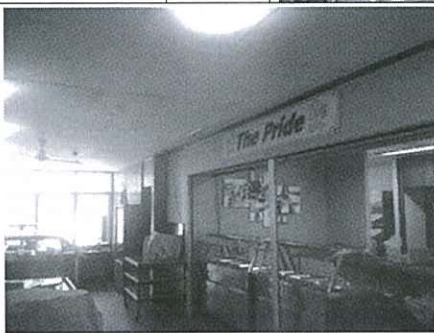
Kitchen / Dining Hall	GL	Dining hall	Asbestos cement sheeting to walls (to service area internally and externally).	NF	N	L	E3198	CH

25/11/2016			No change in the condition of this item.		N	L

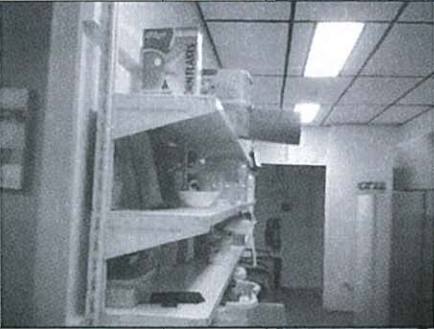
Building	Floor Level	Room	Asbestos in Room	Type	Condition	Priority	Sample No.	Result	Photo
Kitchen / Dining Hall	GL	Kitchen	Asbestos cement sheeting to walls to rear corridor.	NF	N	L	E3197	CH, A

11/2016	No change in the condition of this item.			N	L

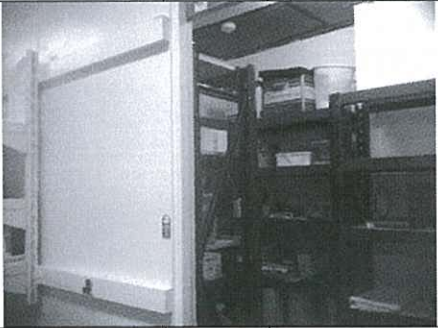
Kitchen / Dining Hall	GL	Rear storeroom	Asbestos cement sheeting to walls.	NF	N	L	E3197	CH, A

Building	Floor Level	Room	Asbestos in Room	Type	Condition	Priority	Sample No.	Result	Photo
25/11/2016			No change in the condition of this item.		N	L

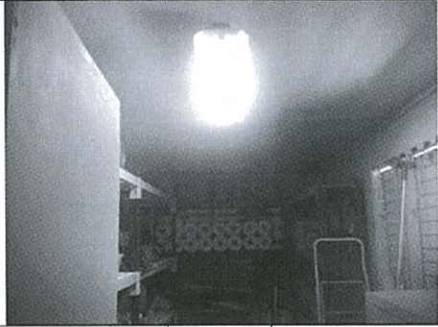
Kitchen / Dining Hall	GL	Cleaners storeroom	Asbestos cement sheeting to ceiling.	NF	N	L	E3197	CH, A	
25/11/2016			No change in the condition of this item.		N	L

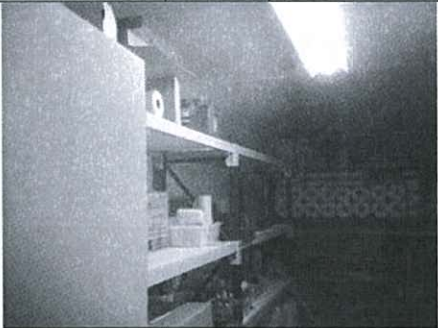
Kitchen / Dining Hall	GL	Cleaners storeroom	Asbestos cement sheeting to walls.	NF	N	L	E3197	CH, A

Building	Floor Level	Room	Asbestos in Room	Type	Condition	Priority	Sample No.	Result	Photo
25/11/2016			No change in the condition of this item.		N	L

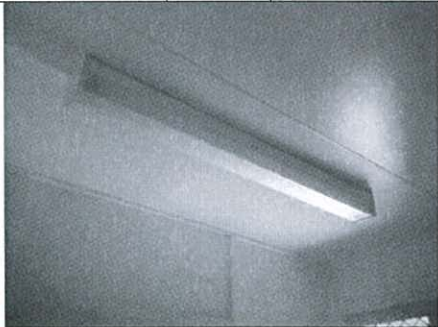
Kitchen / Dining Hall	GL	Rear corridor	Asbestos cement sheeting to ceiling.	NF	N	L	E3197	CH, A	
25/11/2016			No change in the condition of this item.		N	L

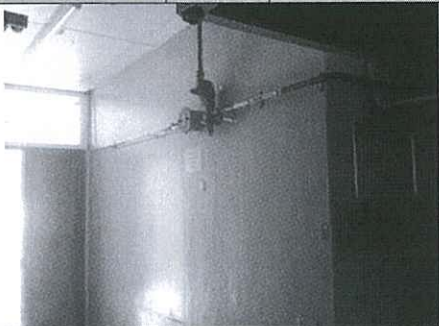
Kitchen / Dining Hall	GL	Rear stores to kitchen	Asbestos cement sheeting to walls externally and internally.	NF	N	L	E3202	CH

Building	Floor Level	Room	Asbestos in Room	Type	Condition	Priority	Sample No.	Result	Photo
25/11/2016			No change in the condition of this item.		N	L

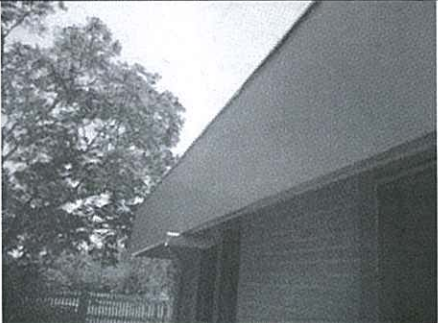
Building	Floor Level	Room	Asbestos in Room	Type	Condition	Priority	Sample No.	Result	Photo
Cottage	GL	External	Asbestos cement sheeting to fascias generally.	NF	N	L	E3204	CH, A

25/11/2016		No change in the condition of this item.			N	L

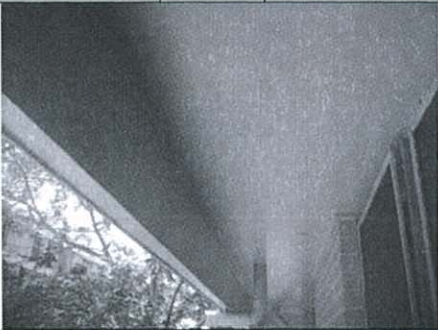
Cottage	GL	External	Asbestos cement sheeting to soffits generally.	NF	G	L	E3204	CH, A

Building	Floor Level	Room	Asbestos in Room	Type	Condition	Priority	Sample No.	Result	Photo
25/11/2016			No change in the condition of this item.		G	L

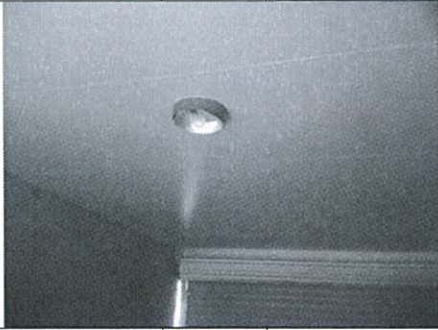
Cottage	GL	Garage	Asbestos cement sheeting to ceiling.	NF	G	L	E3203	CH

25/11/2016			No change in the condition of this item.		G	L

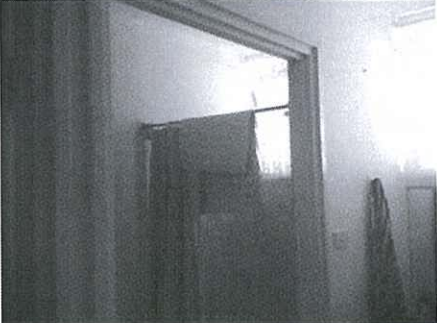
Cottage	GL	Bathroom	Asbestos cement sheeting to walls	NF	G	L	AA	AA

Building	Floor Level	Room	Asbestos in Room	Type	Condition	Priority	Sample No.	Result	Photo
25/11/2016			No change in the condition of this item.		G	L

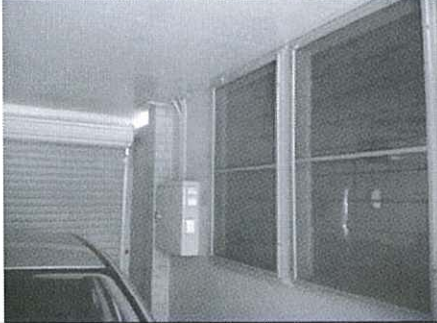
Cottage	GL	Garage	Asbestos cement sheeting to external walls to house.	NF	G	L	E3203	CH

25/11/2016			No change in the condition of this item.		G	L

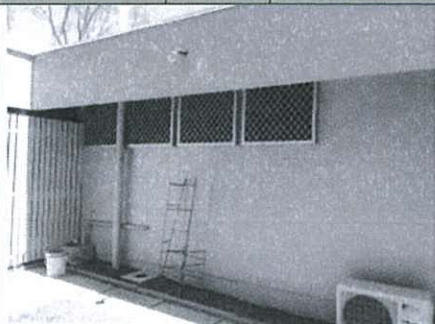
Cottage	GL	External	Asbestos cement sheeting to non brick external walls.	NF	G	L	AA	AA

Building	Floor Level	Room	Asbestos In Room	Type	Condition	Priority	Sample No.	Result	Photo
25/11/2016			No change in the condition of this item.		G	L

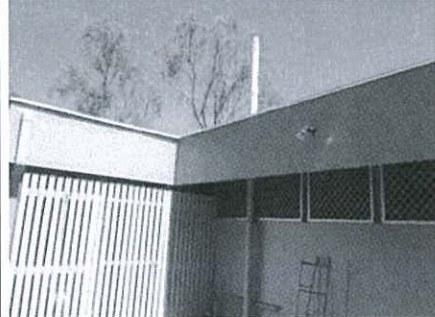
Cottage	GL	External	Assumed Asbestos cement vent pipe.	NF	G	L	AA	AA

25/11/2016			No change in the condition of this item.		G	L

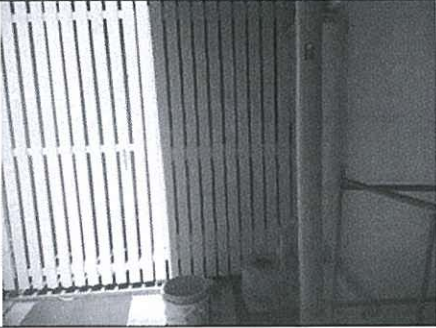
Cottage	GL	External	DT Surround.	NF	G	L	AA	AA

Building	Floor Level	Room	Asbestos in Room	Type	Condition	Priority	Sample No.	Result	Photo
25/11/2016			No change in the condition of this item.		G	L

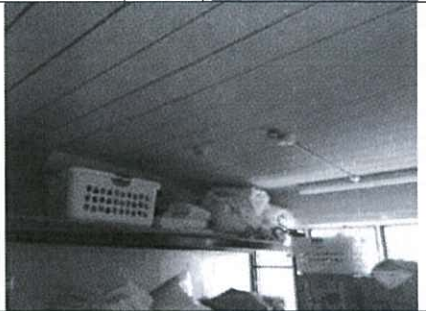
Building	Floor Level	Room	Asbestos in Room	Type	Condition	Priority	Sample No.	Result	Previous Photo
Clark Wing	GL	Storeroom	Asbestos spray material to metal ceiling.	NF	G	L	E3187	CH

5/11/2016	No change in the condition of this item.				G	L

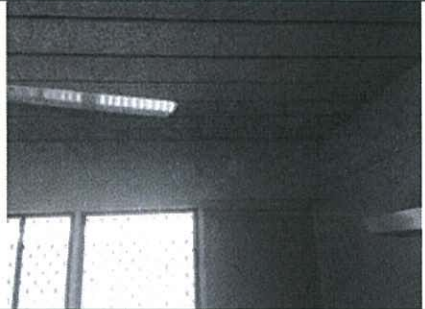
Building	Floor Level	Room	Asbestos in Room	Type	Condition	Priority	Sample No.	Result	Previous Photo
26/11/2016			No change in the condition of this item.		G	L

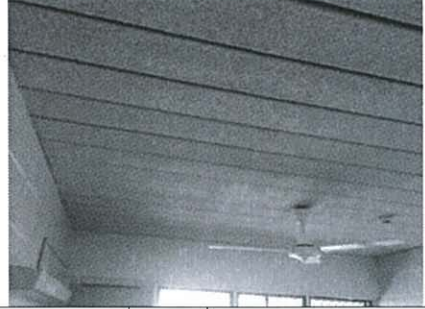
Clark Wing	GL	Room 4	Asbestos spray material to metal ceiling.	NF	G	L	E3187	CH	
26/11/2016			No change in the condition of this item.		G	L

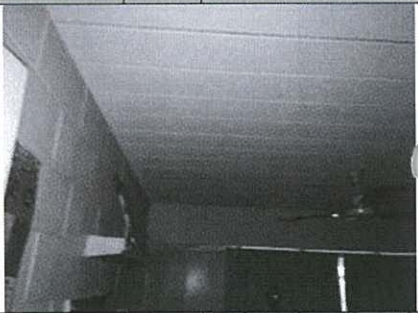
Building	Floor Level	Room	Asbestos In Room	Type	Condition	Priority	Sample No.	Result	Previous Photo
26/11/2016			No change in the condition of this item.		G	L

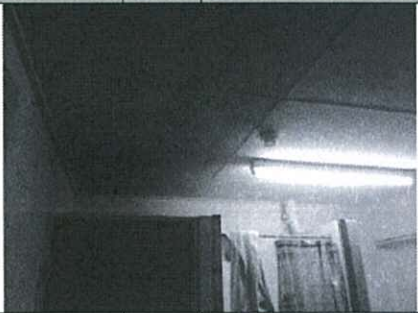
Building	Floor Level	Room	Asbestos in Room	Type	Condition	Priority	Sample No.	Result	Previous Photo
26/11/2016			No change in the condition of this item.		G	L

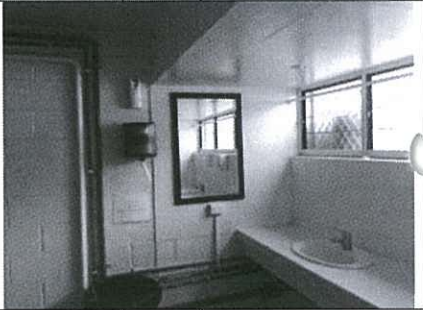
Clark Wing	GL	Bathrooms	Asbestos cement sheeting to front of partition walls.	NF	G	L	S5748	CH

Building	Floor Level	Room	Asbestos in Room	Type	Condition	Priority	Sample No.	Result	Previous Photo
26/11/2016			No change in the condition of this item.		G	L

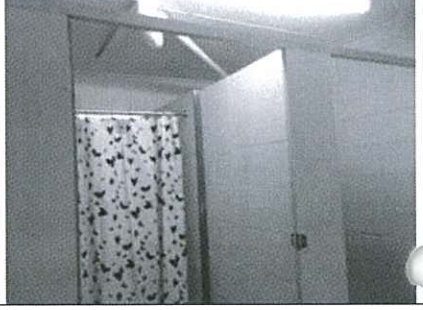
Clark Wing	GL	Bathrooms	Asbestos cement sheeting to front of partition walls.	NF	G	L	S5742	CH

26/11/2016			No change in the condition of this item.		G	L
