# ASBESTOS MATERIALS REPORT AND REGISTER

St Mark's College,  
James Cook University  
DOUGLAS QLD 4811

**Inspection Date:** 23/11/2016 9:00:00 AM

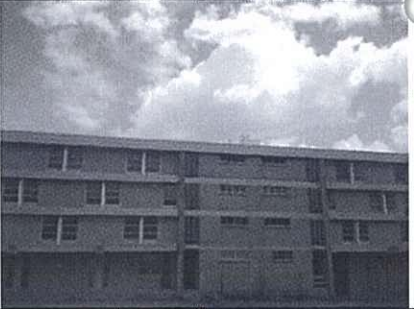
McGregor Wing	GL	External - West stairwell	Asbestos cement sheeting to ceiling to awning and fascia panels.	NF	G	L	E3206	CH

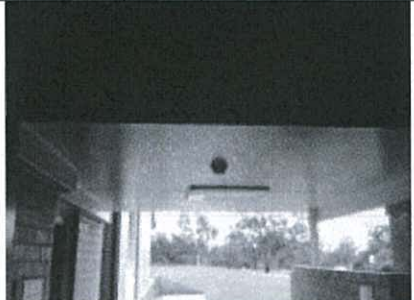
McGregor Wing	3rd	External	Assumed Asbestos cement sheeting to fascias.	NF	G	L	AA	AA

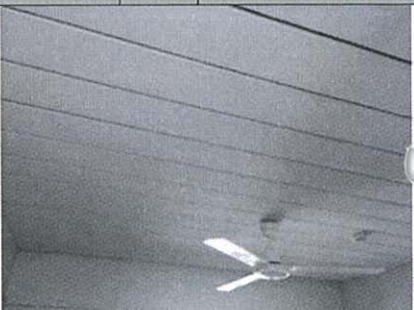
Clark Wing	GL	Room 1	Asbestos cement sheeting to walls above window and door.	NF	G	L	E3185	CH	
26/11/2016			No change in the condition of this item.		G	L

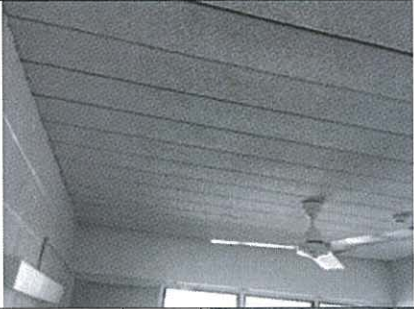
Clark Wing	GL	Room 2	Asbestos spray material to metal ceiling.	NF	G	L	E3187	CH

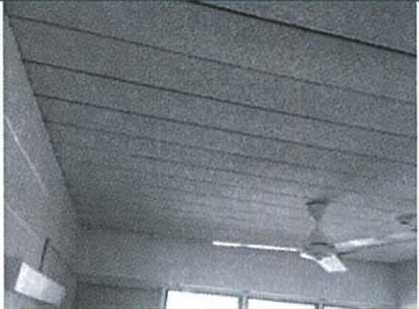
Clark Wing	GL	Room 2	Asbestos cement sheeting to walls above window and door.	NF	G	L	E3185	CH	
26/11/2016			No change in the condition of this item.		G	L

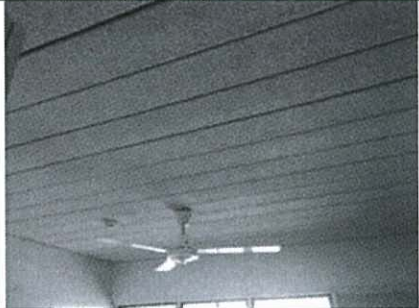
Clark Wing	GL	Hot water room	Asbestos spray material to metal ceiling.	NF	G	L	E3187	CH

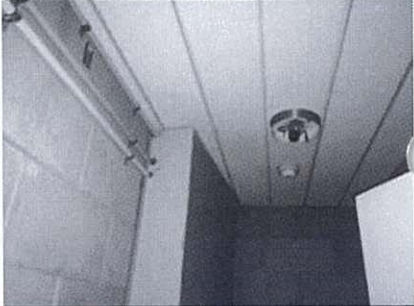
Clark Wing	GL	Room 3	Asbestos spray material to metal ceiling.	NF	G	L	E3187	CH

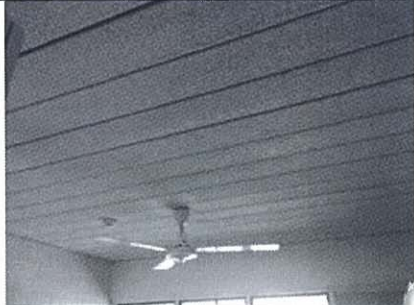
Clark Wing	GL	Room 3	Asbestos cement sheeting to walls above window and door.	NF	G	L	E3185	CH

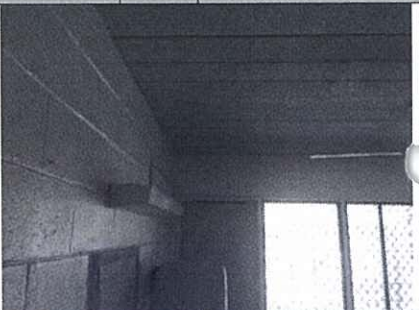
Clark Wing	GL	Room 5	Asbestos spray material to metal ceiling.	NF	G	L	E3187	CH

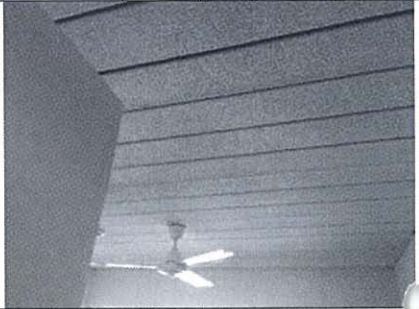
Clark Wing	GL	Room 5	Asbestos cement sheeting to walls above window and door.	NF	G	L	E3185	CH

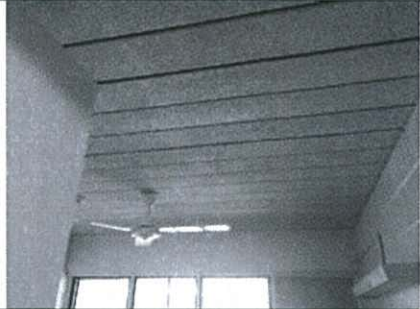
Clark Wing	GL	Room 6	Asbestos spray material to metal ceiling.	NF	G	L	E3187	CH	
26/11/2016			No change in the condition of this item.		G	L

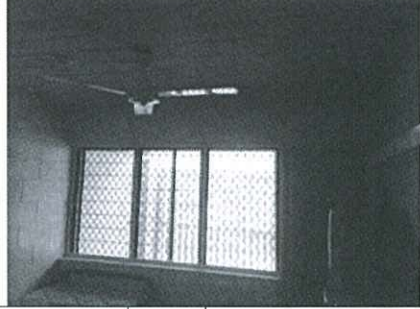
Clark Wing	GL	Room 6	Asbestos cement sheeting to walls above window and door.	NF	G	L	E3185	CH

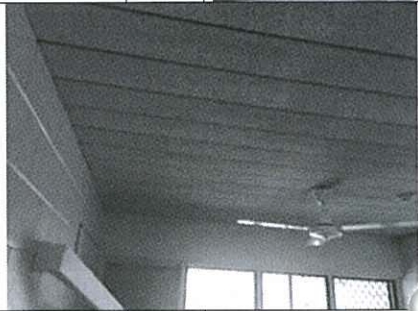
Clark Wing	GL	Room 7	Asbestos cement sheeting to walls above window and door.	NF	G	L	E3185	CH

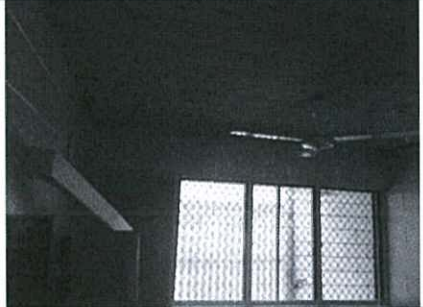
Clark Wing	GL	Room 8	Asbestos spray material to metal ceiling.	NF	G	L	E3187	CH

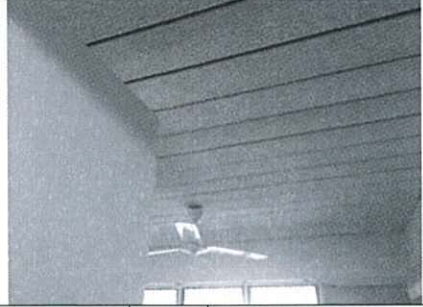
Clark Wing	GL	Room 8	Asbestos cement sheeting to walls above window and door.	NF	G	L	E3185	CH	
26/11/2016			No change in the condition of this item.		G	L

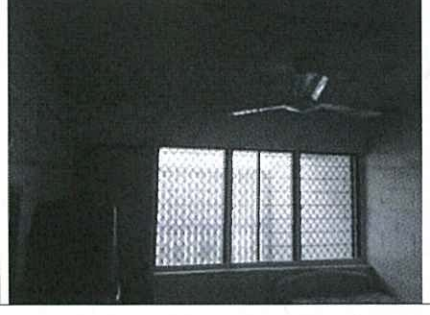
Clark Wing	GL	Room 21	Asbestos cement sheeting to walls above window and door.	NF	G	L	E3185	CH	
26/11/2016			No change in the condition of this item.		G	L			
Clark Wing	GL	Room 22	Asbestos spray material to metal ceiling.	NF	G	L	E3187	CH

26/11/2016			No change in the condition of this item.		G	L

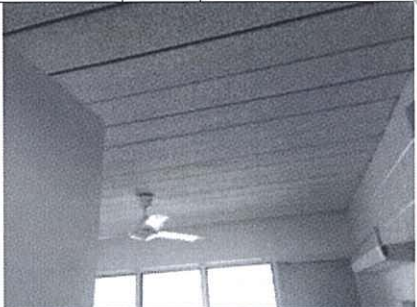
Building	Floor Level	Room	Asbestos in Room	Type	Condition	Priority	Sample No.	Result	Previous Photo
Clark Wing	GL	Room 22	Asbestos cement sheeting to walls above window and door.	NF	G	L	E3185	CH	
26/11/2016		No change in the condition of this item.			G	L			
Clark Wing	GL	Bathroom Room 22	Asbestos cement sheeting to ceiling.	NF	G	L	E3186	CH	
26/11/2016		No change in the condition of this item.			G	L

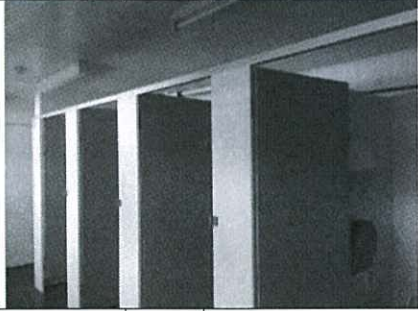
Clark Wing	GL	Bathrooms	Asbestos cement sheeting to wall behind mirror.	NF	G	L	S5742	CH

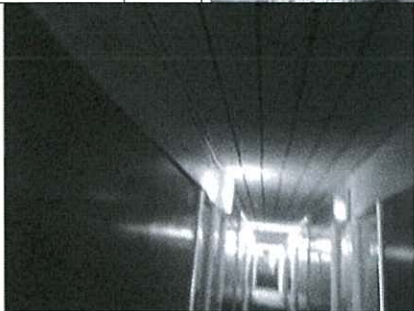
Clark Wing	GL	Hallway	Asbestos cement sheeting to walls above each unit from Unit 4 to Unit 22 internal and external.	NF	G	L	E3186	CH

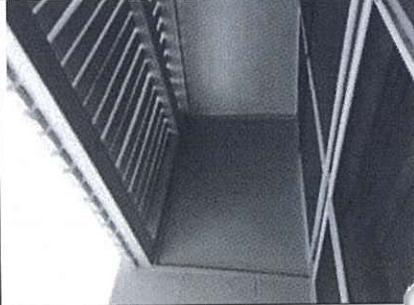
Clark Wing	1st	Bathrooms	Asbestos cement sheeting to front of partition walls.	NF	G	L	S5742	CH

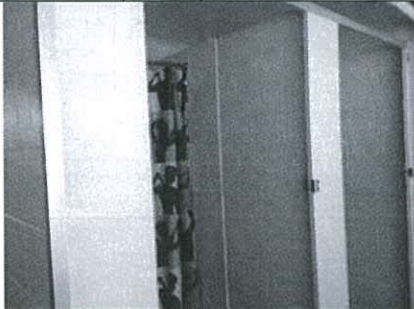
Clark Wing	1st	Bathroom	Asbestos cement sheeting to ceiling.	NF	G	L	E3185	CH

26/11/2016			No change in the condition of this item.		G	L

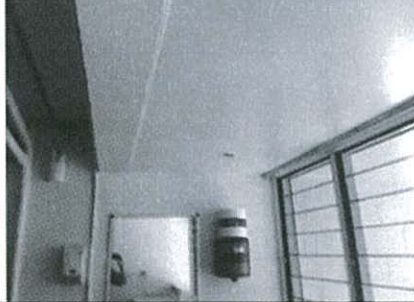
Building	Floor Level	Room	Asbestos in Room	Type	Condition	Priority	Sample No.	Result	Previous Photo
Clark Wing	1st	Room 23	Asbestos spray material to metal ceiling.	NF	G	L	E3184	CH

26/11/2016		No change in the condition of this item.			G	L

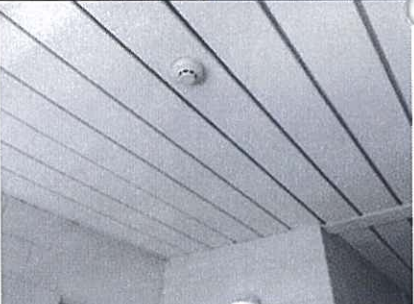
Clark Wing	GL	Room 23	Asbestos cement sheeting to walls above window and door.	NF	G	L	E3185	CH	
26/11/2016		No change in the condition of this item.			G	L			
Clark Wing	1st	Room 24	Asbestos cement sheeting to ceiling.	NF	G	L	E3185	CH

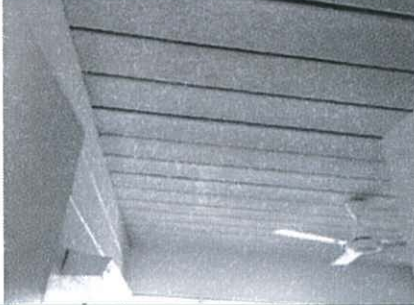
Clark Wing	GL	Room 24	Asbestos cement sheeting to walls above window and door.	NF	G	L	E3185	CH	
27/11/2014			No change in the condition of this item.		G	L

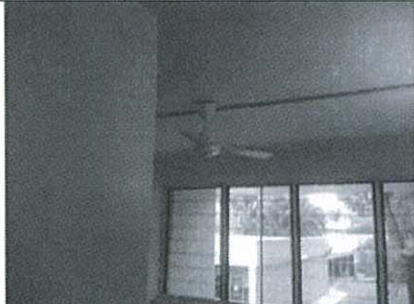
Clark Wing	1st	Room 25	Asbestos spray material to metal ceiling.	NF	G	L	E3184	CH

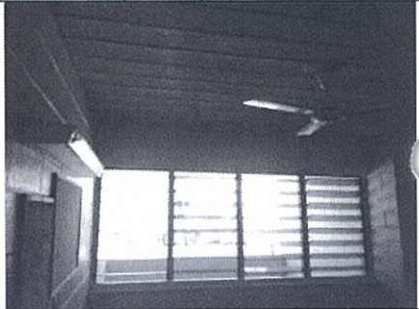
Clark Wing	GL	Room 25	Asbestos cement sheeting to walls above window and door.	NF	G	L	E3185	CH	
26/11/2016			No change in the condition of this item.		G	L			
Clark Wing	1st	Room 26	Asbestos spray material to metal ceiling.	NF	G	L	E3184	CH

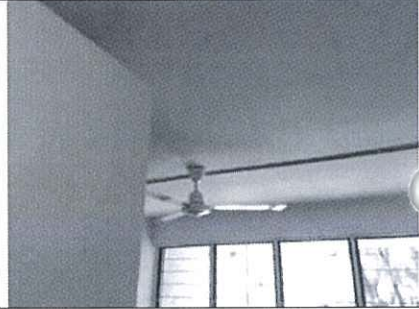
Building	Floor Level	Room	Asbestos In Room	Type	Condition	Priority	Sample No.	Result	Previous Photo
Clark Wing	GL	Room 26	Asbestos cement sheeting to walls above window and door.	NF	G	L	E3185	CH	
26/11/2016		No change in the condition of this item.			G	L			
Clark Wing	1st	Room 27	Asbestos spray material to metal ceiling.	NF	G	L	E3184	CH

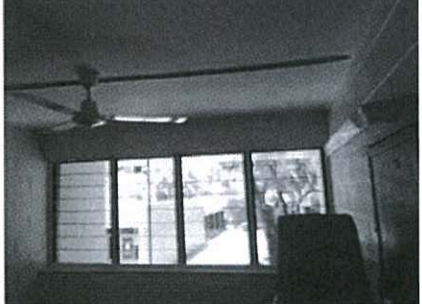
Clark Wing	GL	Room 27	Asbestos cement sheeting to walls above window and door.	NF	G	L	E3185	CH	
26/11/2016		No change in the condition of this item.			G	L			
Clark Wing	1st	Room 28	Asbestos cement sheeting to ceiling.	NF	G	L	E3185	CH

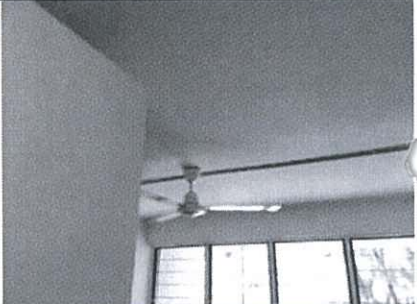
Clark Wing	1st	Room 28	Asbestos cement sheeting to walls above window and door.	NF	G	L	E3185	CH

26/11/2016			No change in the condition of this item.		G	L

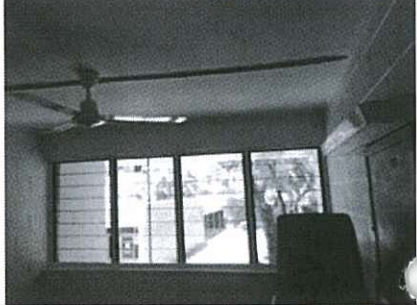
Building	Floor Level	Room	Asbestos In Room	Type	Condition	Priority	Sample No.	Result	Previous Photo
Clark Wing	1st	Room 29	Asbestos spray material to metal ceiling.	NF	G	L	E3184	CH

25/11/2016	No change in the condition of this item.				G	L

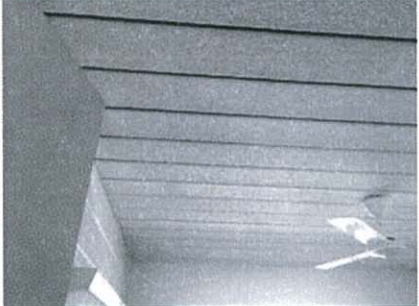
Clark Wing	1st	Room 29	Asbestos cement sheeting to walls above window and door.	NF	G	L	E3185	CH	
26/11/2016	No change in the condition of this item.				G	L

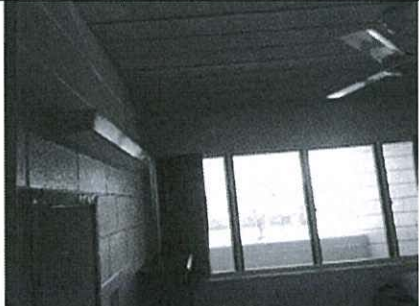
Building	Floor Level	Room	Asbestos in Room	Type	Condition	Priority	Sample No.	Result	Previous Photo
Clark Wing	1st	Room 30	Asbestos cement sheeting to ceiling.	NF	G	L	E3185	CH

26/11/2016		No change in the condition of this item.			G	L

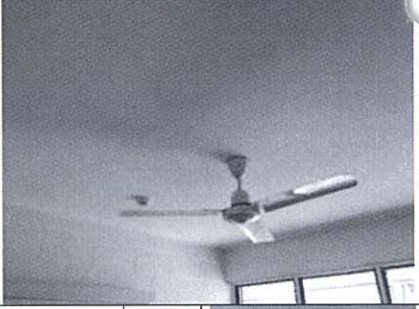
Clark Wing	1st	Room 30	Asbestos cement sheeting to walls above window and door.	NF	G	L	E3185	CH

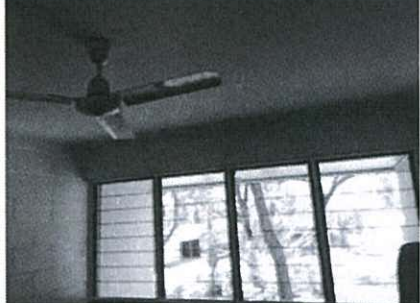
Clark Wing	1st	Room 31	Asbestos spray material to metal ceiling.	NF	G	L	E3184	CH

26/11/2016			No change in the condition of this item.		G	L

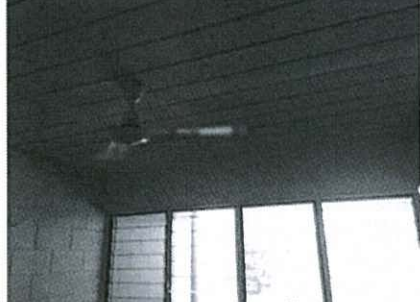
Clark Wing	1st	Room 31	Asbestos cement sheeting to walls above window and door.	NF	G	L	E3185	CH

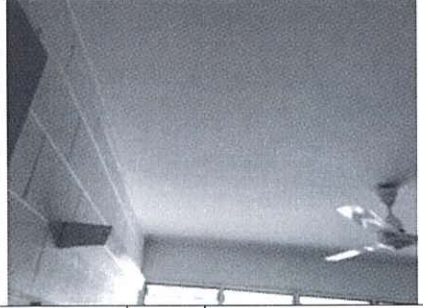
Clark Wing	1st	Room 32	Asbestos cement sheeting to walls above window and door.	NF	G	L	E3185	CH

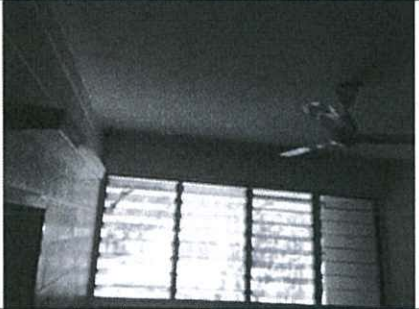
Clark Wing	1st	Room 33	Asbestos spray material to metal ceiling.	NF	G	L	E3184	CH

26/11/2016			No change in the condition of this item.		G	L

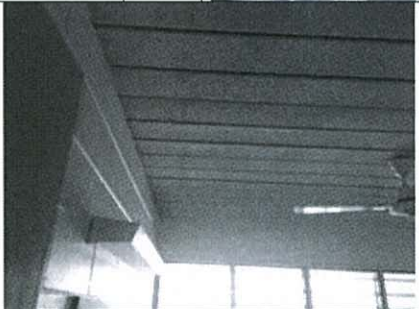
Clark Wing	1st	Room 33	Asbestos cement sheeting to walls above window and door.	NF	G	L	E3185	CH

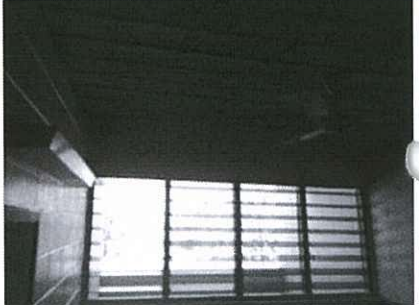
Clark Wing	1st	Common room	Asbestos cement sheeting to ceiling.	NF	G	L	E3185	CH

26/11/2016			No change in the condition of this item.		G	L

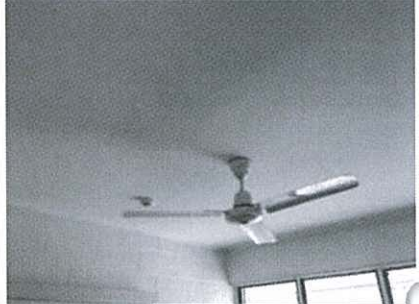
Clark Wing	1st	Common Room	Asbestos cement sheeting to walls above window and door.	NF	G	L	E3185	CH

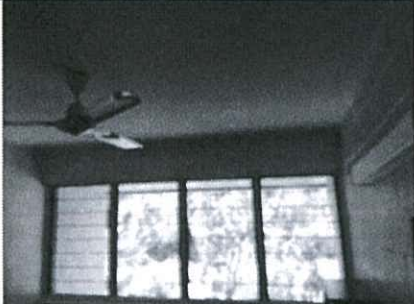
Clark Wing	1st	Bathroom	Asbestos cement sheeting to ceiling.	NF	G	L	E3185	CH

26/11/2016			No change in the condition of this item.		G	L

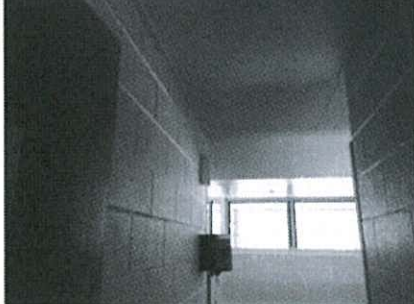
Building	Floor Level	Room	Asbestos in Room	Type	Condition	Priority	Sample No.	Result	Previous Photo
Clark Wing	1st	Room 34	Asbestos cement sheeting to ceiling.	NF	G	L	E3185	CH

26/11/2016		No change in the condition of this item.			G	L

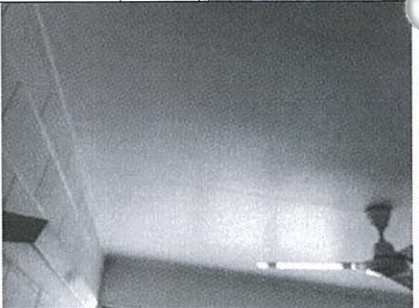
Clark Wing	1st	Room 34	Asbestos cement sheeting to walls above window and door.	NF	G	L	E3185	CH

26/11/2016		No change in the condition of this item.			G	L

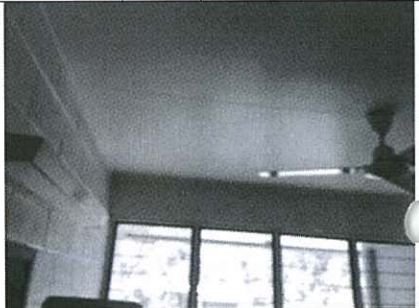
Building	Floor Level	Room	Asbestos in Room	Type	Condition	Priority	Sample No.	Result	Previous Photo
Clark Wing	1st	Room 35	Asbestos spray material to metal ceiling.	NF	G	L	E3184	CH

11/11/2016	No change in the condition of this item.			G	L

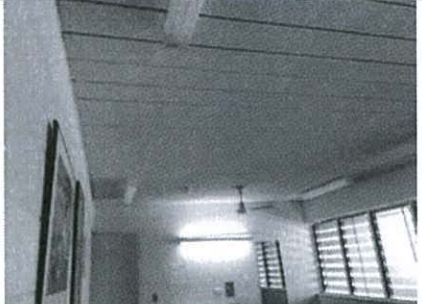
Clark Wing	1st	Room 36	Asbestos cement sheeting to ceiling.	NF	G	L	E3185	CH

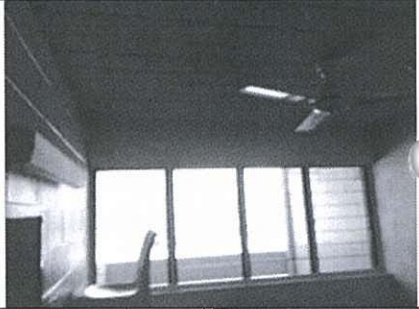
Clark Wing	1st	Room 36	Asbestos cement sheeting to walls above window and door.	NF	G	L	E3185	CH

26/11/2016			No change in the condition of this item.		G	L

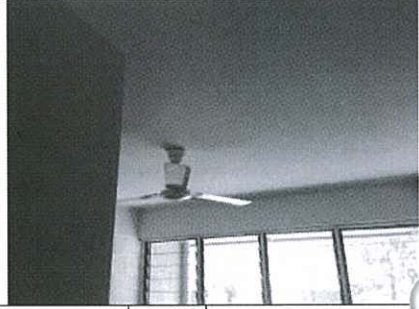
Clark Wing	1st	Room 37	Asbestos cement sheeting to walls above window and door.	NF	G	L	E3185	CH

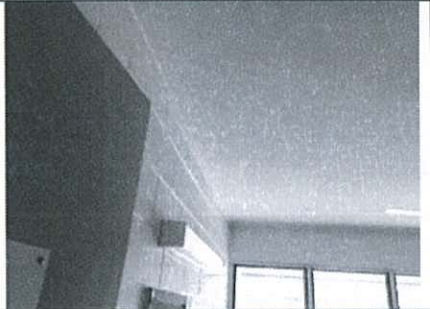
Clark Wing	1st	Room 37	Asbestos spray material to metal ceiling.	NF	G	L	E3184	CH

26/11/2016			No change in the condition of this item.		G	L

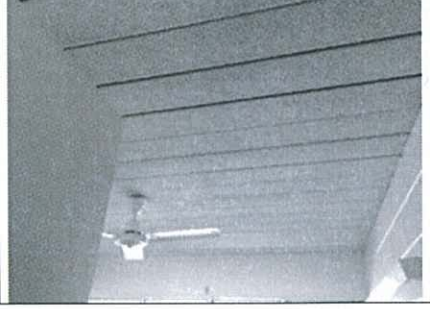
Building	Floor Level	Room	Asbestos In Room	Type	Condition	Priority	Sample No.	Result	Previous Photo
Clark Wing	1st	Room 38	Asbestos cement sheeting to ceiling.	NF	G	L	E3185	CH

26/11/2016		No change in the condition of this item.			G	L

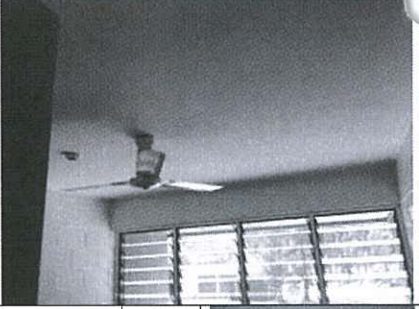
Clark Wing	1st	Room 38	Asbestos cement sheeting to walls above window and door.	NF	G	L	E3185	CH

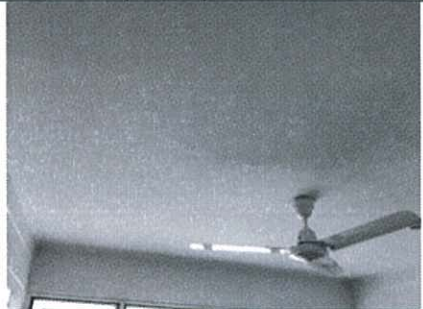
Clark Wing	1st	Room 39	Asbestos spray material to metal ceiling.	NF	G	L	E3184	CH

26/11/2016			No change in the condition of this item.		G	L

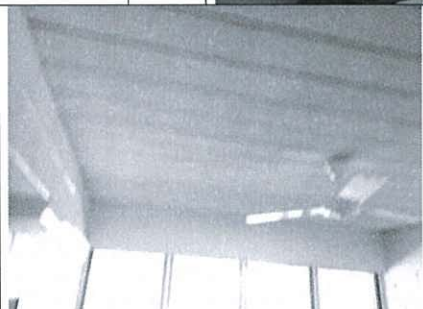
Building	Floor Level	Room	Asbestos in Room	Type	Condition	Priority	Sample No.	Result	Previous Photo
Clark Wing	1st	Room 39	Asbestos cement sheeting to walls above window and door.	NF	G	L	E3185	CH

26/11/2016		No change in the condition of this item.			G	L

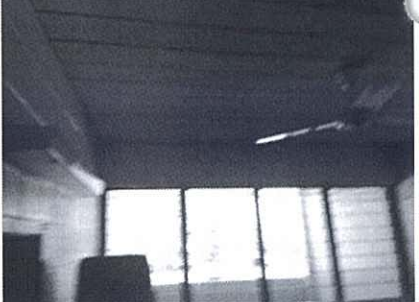
Clark Wing	1st	Room 40	Asbestos cement sheeting to ceiling.	NF	G	L	E3185	CH

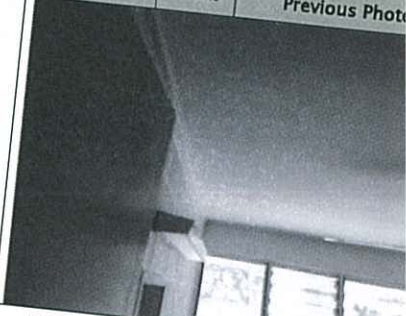
Clark Wing	1st	Room 40	Asbestos cement sheeting to walls above window and door.	NF	G	L	E3185	CH

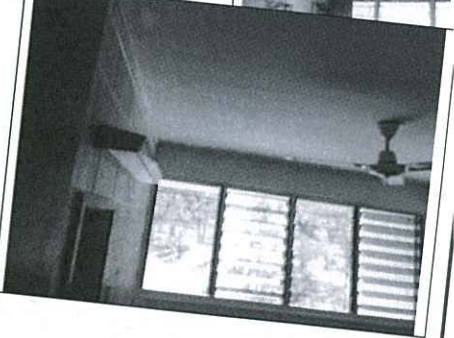
Building	Floor Level	Room	Asbestos In Room	Type	Condition	Priority	Sample No.	Result	Previous Photo
Clark Wing	1st	Room 41	Asbestos spray material to metal ceiling.	NF	G	L	E3184	CH

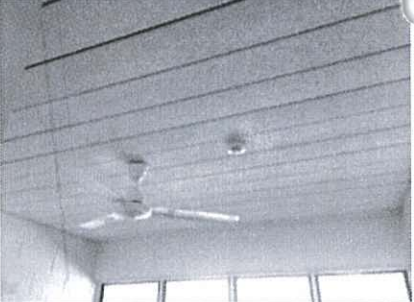
Clark Wing	1st	Room 41	Asbestos cement sheeting to walls above window and door.	NF	G	L	E3185	CH

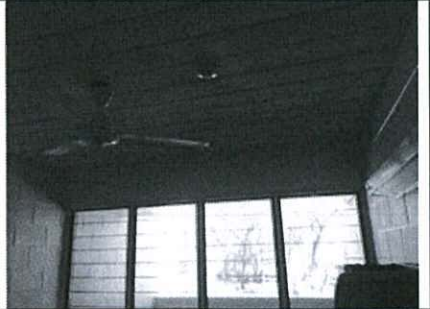
Clark Wing	1st	Room 42	Asbestos cement sheeting to ceiling.	NF	G	L	E3185	CH

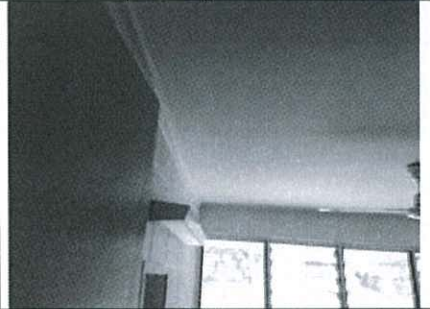
Building	Floor Level	Room	Asbestos in Room	Type	Condition	Priority	Sample No.	Result	Previous Photo
Clark Wing	1st	Room 42	Asbestos cement sheeting to walls above window and door.	NF	G	L	E3185	CH

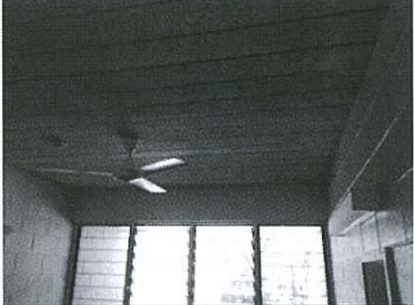
Clark Wing	1st	Room 43	Asbestos cement sheeting to walls above window and door.	NF	G	L	E3185	CH

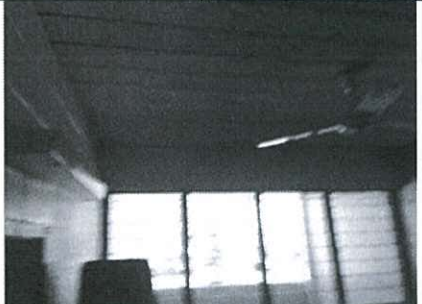
Clark Wing	1st	Room 44	Asbestos cement sheeting to walls above window and door.	NF	G	L	E3185	CH

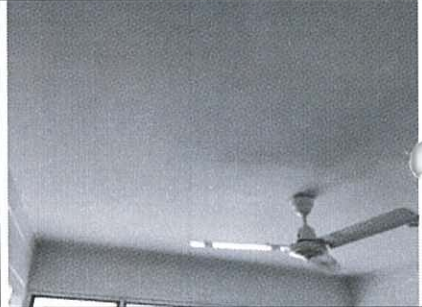
Clark Wing	1st	Room 45 - rear room	Asbestos cement sheeting to walls above window and door.	NF	G	L	E3185	CH

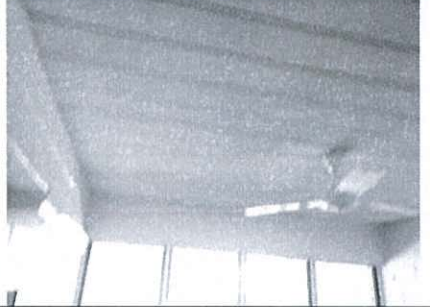
Clark Wing	1st	Balcony - West elevation	Asbestos cement sheeting to ceiling and walls panels.	NF	G	L	E3185	CH

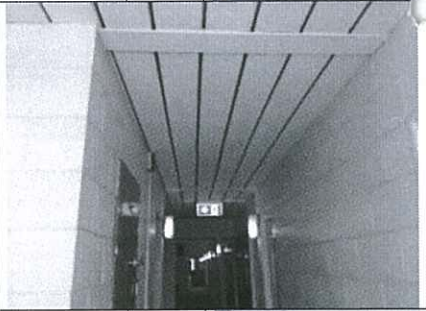
Clark Wing	1st	Hallway	Asbestos cement sheeting to walls.	NF	G	L	E3185	CH

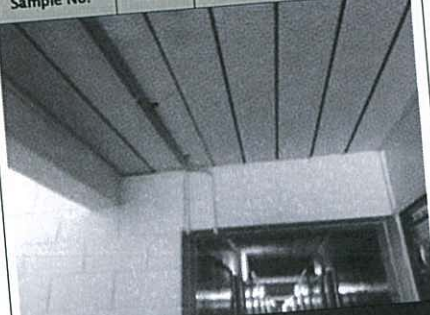
Clark Wing	1st	Bathroom	Asbestos cement sheeting to ceiling.	NF	G	L	E3185	CH

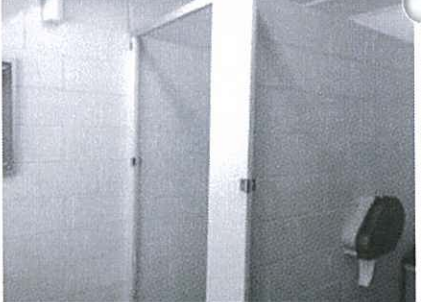
Clark Wing	1st	Bathroom	Asbestos cement sheeting to ceiling.	NF	G	L	E3185	CH

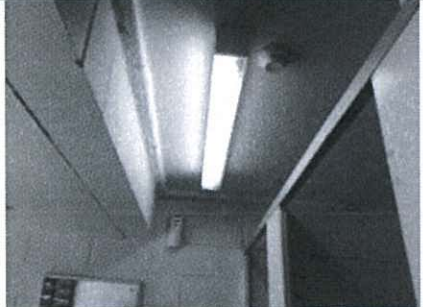
Clark Wing	1st	Bathroom	Asbestos cement partition to walls.	NF	G	L	E3185	CH

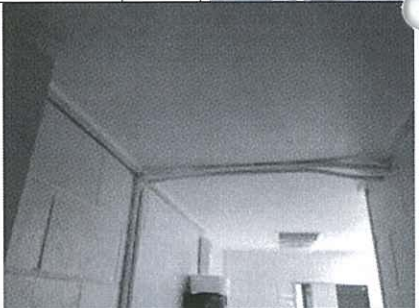
Clark Wing	2nd	Middle Bathroom	Asbestos cement sheeting to ceiling and walls of skylight.	NF	G	L	E3210	CH

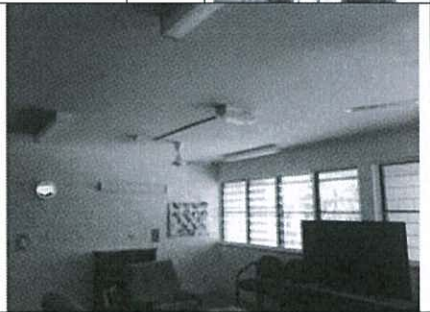
Building	Floor Level	Room	Asbestos in Room	Type	Condition	Priority	Sample No.	Result	Previous Photo
Clark Wing	2nd	Common room	Asbestos cement sheeting to walls above window and door.	NF	G	L	E3210	CH

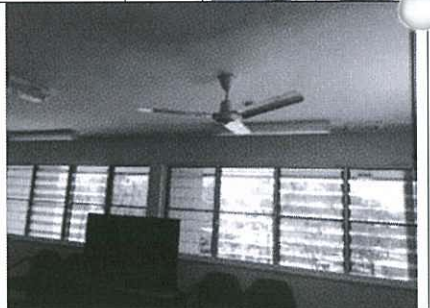
Clark Wing	2nd	Room 58	Asbestos cement sheeting to non masonry walls.	NF	G	L	E3210	CH	
26/11/2016	No change in the condition of this item.				G	L

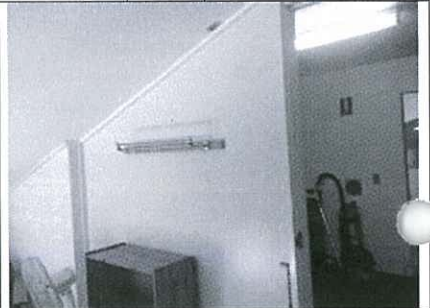
Clark Wing	2nd	Room 58	Asbestos cement sheeting to walls	NF	G	L	E3210	CH

Building	Floor Level	Room	Asbestos In Room	Type	Condition	Priority	Sample No.	Result	Previous Photo
			above window and door.						
26/11/2016			No change in the condition of this item.		G	L

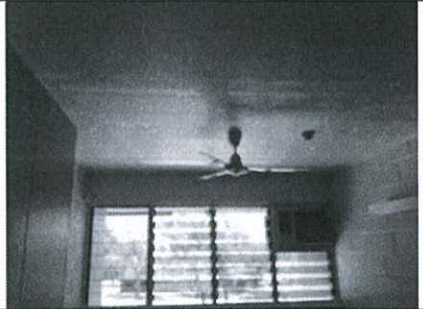
Clark Wing	2nd	Room 58	Asbestos cement sheeting to ceiling.	NF	G	L	E3210	CH	
26/11/2016			No change in the condition of this item.		G	L

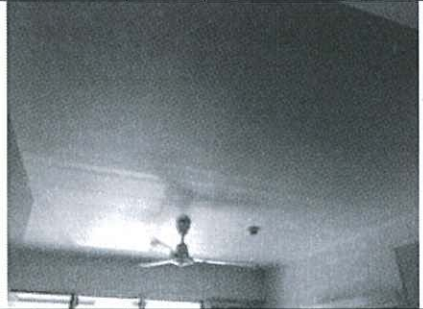
Clark Wing	2nd	Room 46	Asbestos cement sheeting to ceiling.	NF	G	L	E3210	CH

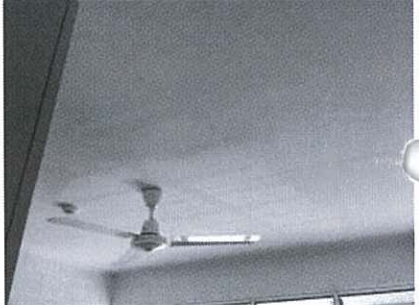
Clark Wing	2nd	Room 46	Asbestos cement sheeting to walls above window and door.	NF	G	L	E3210	CH

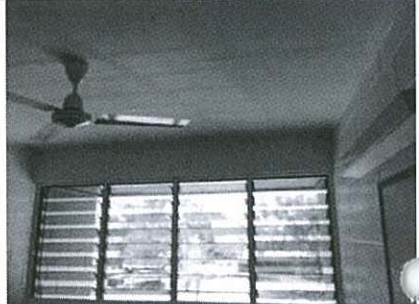
Building	Floor Level	Room	Asbestos In Room	Type	Condition	Priority	Sample No.	Result	Previous Photo
Clark Wing	2nd	Room 47	Asbestos cement sheeting to ceiling.	NF	G	L	E3210	CH

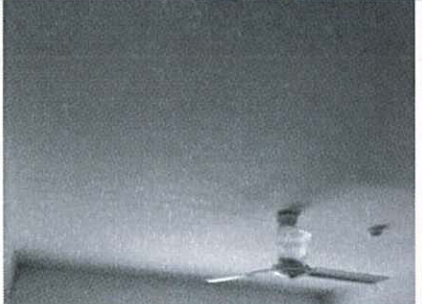
Clark Wing	2nd	Room 47	Asbestos cement sheeting to walls above window and door.	NF	G	L	E3210	CH

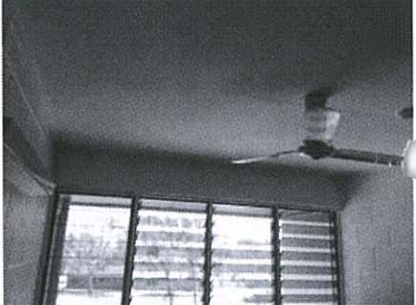
Clark Wing	2nd	Room 48	Asbestos cement sheeting to ceiling.	NF	G	L	E3210	CH

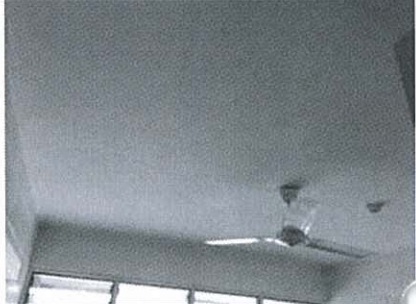
Building	Floor Level	Room	Asbestos in Room	Type	Condition	Priority	Sample No.	Result	Previous Photo
Clark Wing	2nd	Room 48	Asbestos cement sheeting to walls above window and door.	NF	G	L	E3210	CH

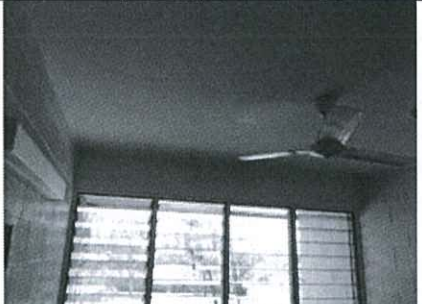
Clark Wing	2nd	Room 49	Asbestos cement sheeting to ceiling.	NF	G	L	E3210	CH

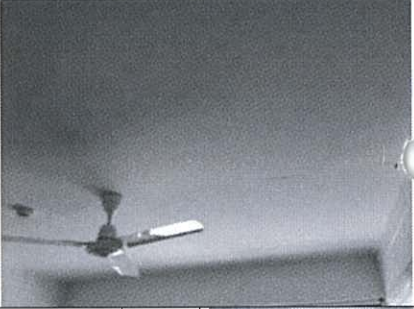
Clark Wing	2nd	Room 49	Asbestos cement sheeting to walls above window and door.	NF	G	L	E3210	CH

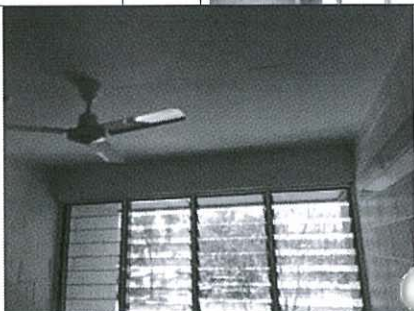
Building	Floor Level	Room	Asbestos in Room	Type	Condition	Priority	Sample No.	Result	Previous Photo
Clark Wing	2nd	Room 50	Asbestos cement sheeting to ceiling.	NF	G	L	E3210	CH

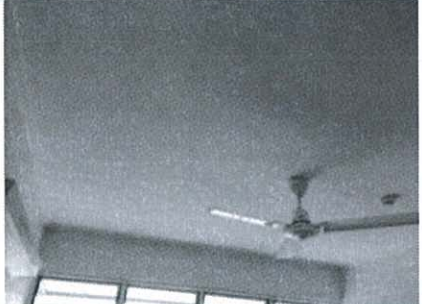
Clark Wing	2nd	Room 50	Asbestos cement sheeting to walls above window and door.	NF	G	L	E3210	CH

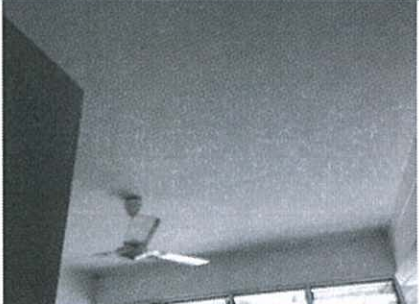
Clark Wing	2nd	Room 51	Asbestos cement sheeting to walls above window and door.	NF	G	L	E3210	CH

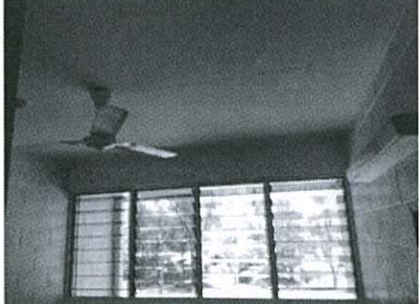
Building	Floor Level	Room	Asbestos In Room	Type	Condition	Priority	Sample No.	Result	Previous Photo
Clark Wing	2nd	Room 52	Asbestos cement sheeting to ceiling.	NF	G	L	E3210	CH

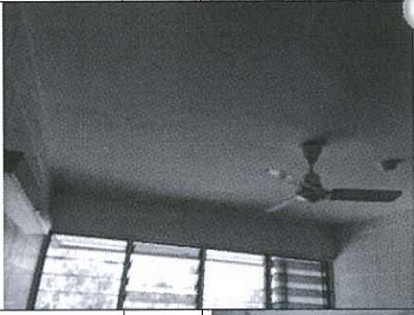
Clark Wing	2nd	Room 52	Asbestos cement sheeting to walls above window and door.	NF	G	L	E3210	CH

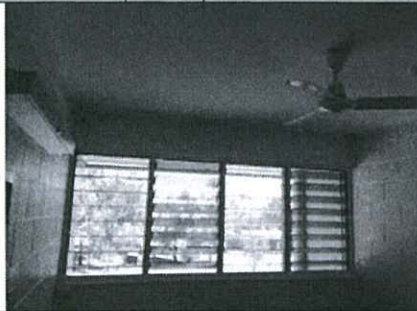
Clark Wing	2nd	Room 53	Asbestos cement sheeting to ceiling.	NF	G	L	E3210	CH

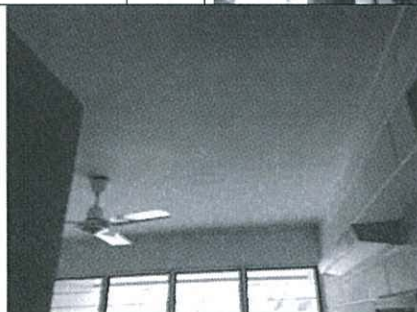
Building	Floor Level	Room	Asbestos in Room	Type	Condition	Priority	Sample No.	Result	Previous Photo
Clark Wing	2nd	Room 53	Asbestos cement sheeting to walls above window and door.	NF	G	L	E3210	CH

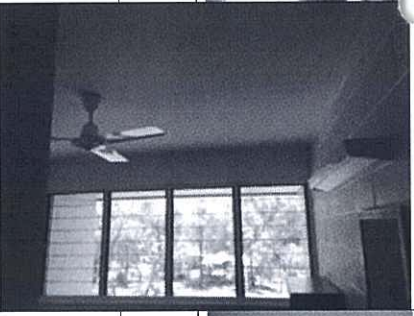
Clark Wing	2nd	Room 54	Asbestos cement sheeting to ceiling.	NF	G	L	E3210	CH

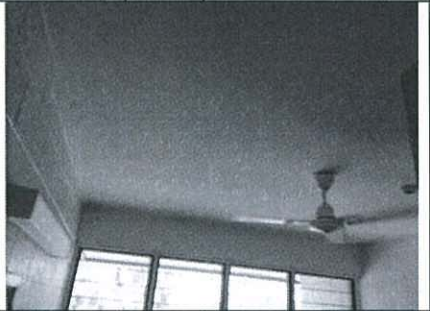
Clark Wing	2nd	Room 54	Asbestos cement sheeting to walls above window and door.	NF	G	L	E3210	CH

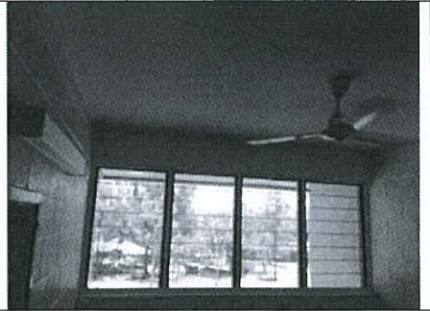
26/11/2016			No change in the condition of this item.		G	L

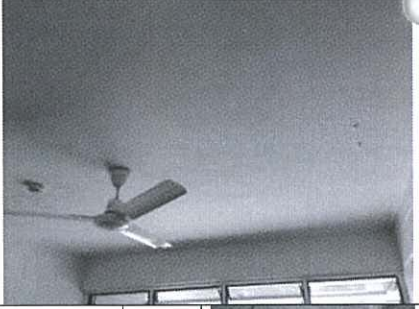
Building	Floor Level	Room	Asbestos in Room	Type	Condition	Priority	Sample No.	Result	Previous Photo
Clark Wing	2nd	Room 55	Asbestos cement sheeting to ceiling.	NF	G	L	E3210	CH

26/11/2016		No change in the condition of this item.			G	L

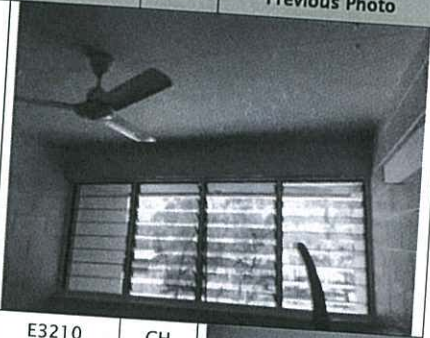
Clark Wing	2nd	Room 55	Asbestos cement sheeting to walls above window and door.	NF	G	L	E3210	CH

Building	Floor Level	Room	Asbestos in Room	Type	Condition	Priority	Sample No.	Result	Previous Photo
26/11/2016			No change in the condition of this item.		G	L

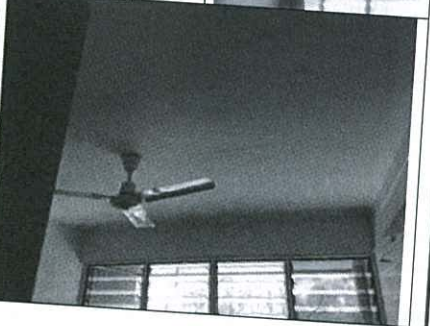
Clark Wing	2nd	Room 56	Asbestos cement sheeting to ceiling.	NF	G	L	E3210	CH

26/11/2016			No change in the condition of this item.		G	L

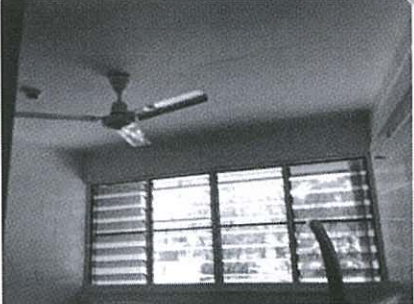
Building	Floor Level	Room	Asbestos in Room	Type	Condition	Priority	Sample No.	Result	Previous Photo
Clark Wing	2nd	Room 56	Asbestos cement sheeting to walls above window and door.	NF	G	L	E3210	CH

26/11/2016		No change in the condition of this item.			G	L

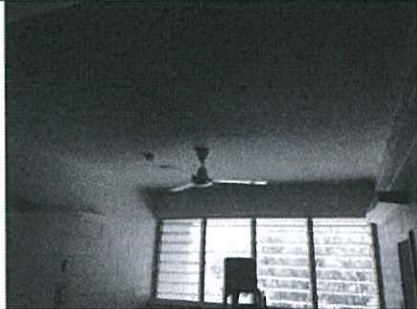
Clark Wing	2nd	Room 57	Asbestos cement sheeting to ceiling throughout.	NF	G	L	E3210	CH

Building	Floor Level	Room	Asbestos in Room	Type	Condition	Priority	Sample No.	Result	Previous Photo
26/11/2016			No change in the condition of this item.		G	L

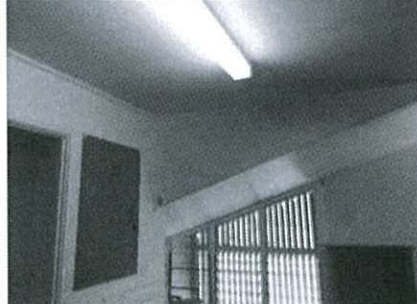
Clark Wing	2nd	Room 57	Asbestos cement sheeting to walls above window and door and non masonry walls throughout.	NF	G	L	E3210	CH

26/11/2016			No change in the condition of this item.		G	L

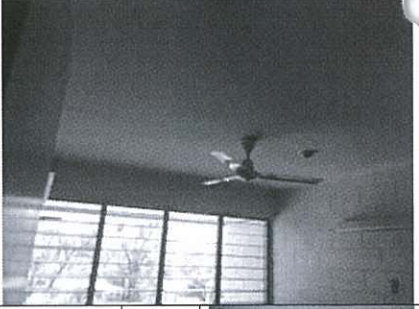
Building	Floor Level	Room	Asbestos In Room	Type	Condition	Priority	Sample No.	Result	Previous Photo
Clark Wing	2nd	Room 57 common area	Asbestos cement sheeting to wall above and beside windows	NF	G	L	E3210	CH

26/11/2016		No change in the condition of this item.			G	L

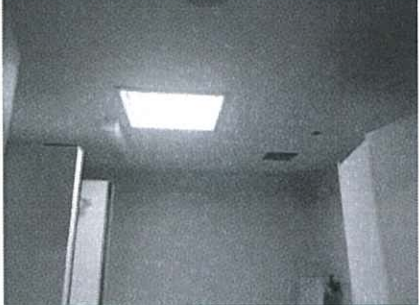
Clark Wing	2nd	Room 57 bathroom	Asbestos cement sheeting to ceiling.	NF	G	L	E3210	CH

Building	Floor Level	Room	Asbestos in Room	Type	Condition	Priority	Sample No.	Result	Previous Photo
26/11/2016			No change in the condition of this item.		G	L

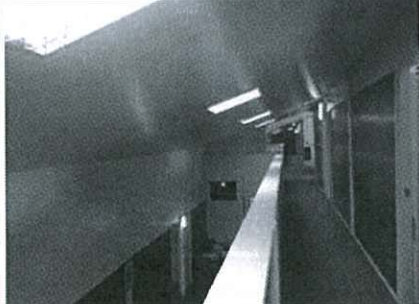
Clark Wing	2nd	Hallway	Asbestos cement sheeting to walls above panels.	NF	G	L	E3210	CH

26/11/2016			No change in the condition of this item.		G	L

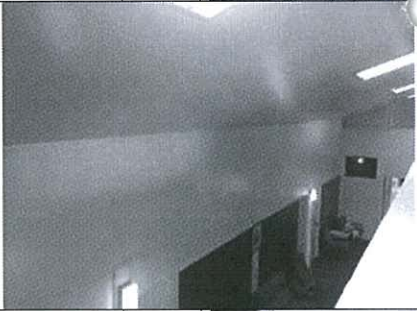
Building	Floor Level	Room	Asbestos in Room	Type	Condition	Priority	Sample No.	Result	Previous Photo
Clark Wing	2nd	Hallway	Asbestos cement sheeting to ceiling.	NF	G	L	E3210	CH

26/11/2016		No change in the condition of this item.			G	L

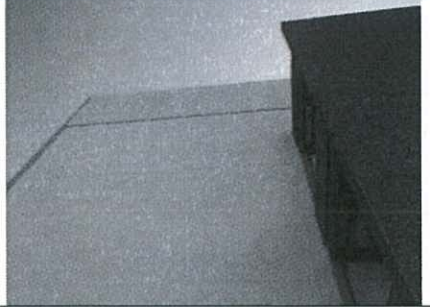
Clark Wing	2nd	External	Assumed Asbestos cement sheeting to soffits.	NF	G	L	AA	AA

Building	Floor Level	Room	Asbestos in Room	Type	Condition	Priority	Sample No.	Result	Previous Photo
26/11/2016			No change in the condition of this item.		G	L
